Docket No. 272 - Development and Management Plan Inspection

Segment 2a Inspection

Date: August 31, 2006

Location: Segment 2a- Beseck Switching Station to Cheshire/Hamden Town Line

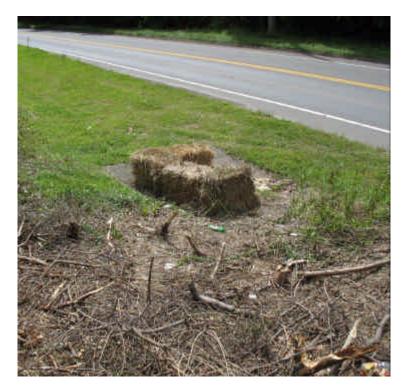
Haybales were installed off Rt. 68 at catch basin inlet.

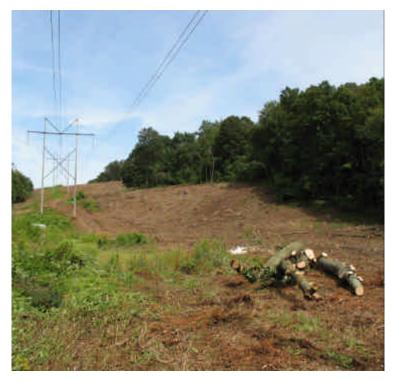
Exposed slope needs water bars and/or other erosion controls.

Areas of Inspection	Observation	Recommended Action	Corrected Action
	8/31/06		
Erosion and sediment controls continued	A fairly steep, exposed hill on site needs some stormwater controls to prevent erosion. 8/24-8/31/06	Several ideas for controls were discussed: mulch, wood chips, fiber mats, and water bars with grass seed are possible options. Retain as much vegetation as possible. 8/24-8/31/06	Needs attention.
	Catch basin at Route 68 has new haybales installed 8/31/06	Maintain as needed. 8/31/06	Haybales added
	Dust control is needed for the site as disturbed soil is present due to tree skidding and removal. 8/24-8/31/06	Water high traffic areas regularly and stabilize disturbed areas that will be left for more than 14-21 days. Retain as much vegetation as possible. 8/24-8/31/06	Needs attention.
Williams Rd to East Center St.	Silt fence and silt liners were installed at CB near Stony Brook Rd. entrance. 8/31/06	Maintain as needed.	Silt fence and liner installed proactively.

Some erosion prone areas	Create water bars on	NA.

Areas of Inspection	Observation	Recommended Action	Corrected Action
	(i.e. steep slopes) need further stabilization or stormwater diversion. 8/24-8/31/06	slopes or place controls as discussed. 8/24-8/31/06	
	As per the D&M plan, vegetation removal is occurring in upland work, access, and associated assembly areas. 8/24-8/31/06 Due to less invasive species, more vegetation was able to be preserved in the Stony Brook Rd. area. 8/31/06	Retain ground cover wherever feasible to reduce disturbance. Confirm that cutting is limited only to defined work and assembly areas and vegetation is being retained whenever possible. 8/24-8/31/06	Less vegetative disturbance was noted in the new section
	Trees near an adjacent home near High Hill Rd. were being carefully cut by hand. 8/31/06	None 8/31/06	Care was taken near adjacent landowners
Dewatering	Dewatering is not being performed at this time. 8/31/06	None	NA

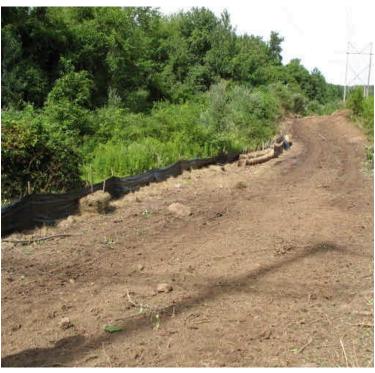
Erosion and sediment controls adjacent to the southern wetland at High Hill Rd.

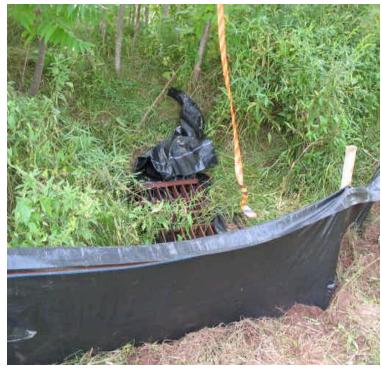
Silt fence and silt liner at catch basin inlet off Stony Brook Rd.

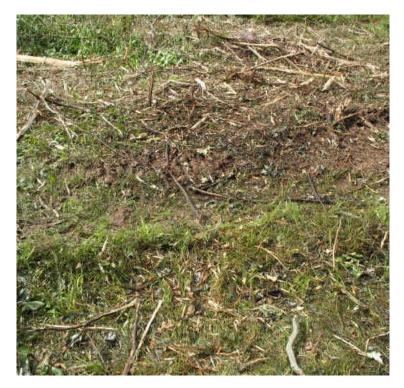
$\label{thm:continuity} \begin{tabular}{ll} Hydraulic fluid spill located off Stony Brook Rd. It was being cleaned by the time the inspector was leaving the site. \end{tabular}$

Blasting	No blasting is proposed at this time, 8/31/06	None	NA
Spills, soils and material storage	Cleared trees and shrubs are being stockpiled at this time and are being chipped on site. 8/24- 8/31/06	Continue to keep all stockpiles set back from wetlands. 8/24-8/31/06	NA
	Spill control materials are onsite. 8/31/06	Always use spill control materials when working on equipment and during refueling. Replace as needed. Also, park all machinery away from the wetlands. 8/24-8/31/06	NA
	Less than 1 gallon of hydraulic fluid was spilled when a hose broke on the Stony Brook Rd. section. The crew had left this area without cleaning up the spill. 8/31/06	Immediately clean and report spills to Burns and McDonnell. Spills/leaks greater than one gallon of fluid must be reported to the CT DEP. 8/31/06	Area was cleaned by the contractor upon notification.
Additional Observations	NA 1	NA	NA

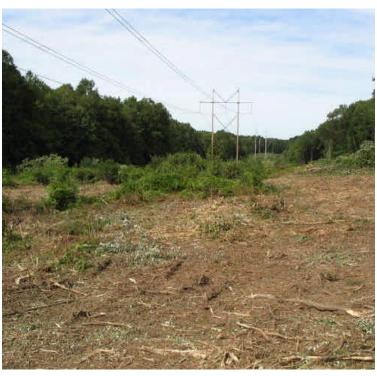
Right-of-way cleared, with vegetation/woody debris left for erosion control.

Much of the appropriate vegetation and woody debris has been retained off Stony Brook Rd to prevent erosion. 8/31/06	Continue to make efforts to retain vegetation for erosion control. 8/31/06	Vegetation left for erosion control.
Inland Wetland and Watercourse encroachment and mitigation	Jurisdictional wetlands will not be accessed until the Army Corps permit is in hand. 8/24-8/31/06	Continue to monitor wetlands and erosion controls. 8/31/06	NA
	Wetlands were flagged at the 100' buffer off Stony Brook Rd. 8/31/06	Maintain buffer zone until ACOE permits allow access. 8/31/06	Buffer zone established.
State species of concern, threatened and endangered species.	According to the D&M plan, state-listed species are not immediately located in the current work area. 8/31/06	None 8/31/06	NA
Vegetative clearing or stabilization	Vegetative clearing is ongoing along sections of the ROW and will continue for several weeks. 8/31/06	None 8/31/06	NA

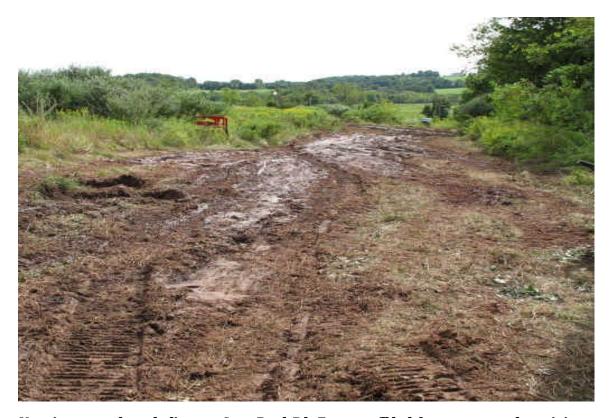
New site entrance located adjacent to Stony Brook Rd. Entrance will be left to revegetate and an existing roadway will be rebuilt along the wetland once permits are obtained.
